Failure Investigation

Root-Cause Analysis of Failed Submerged Electrical Cables

Dr. A. R. Langley

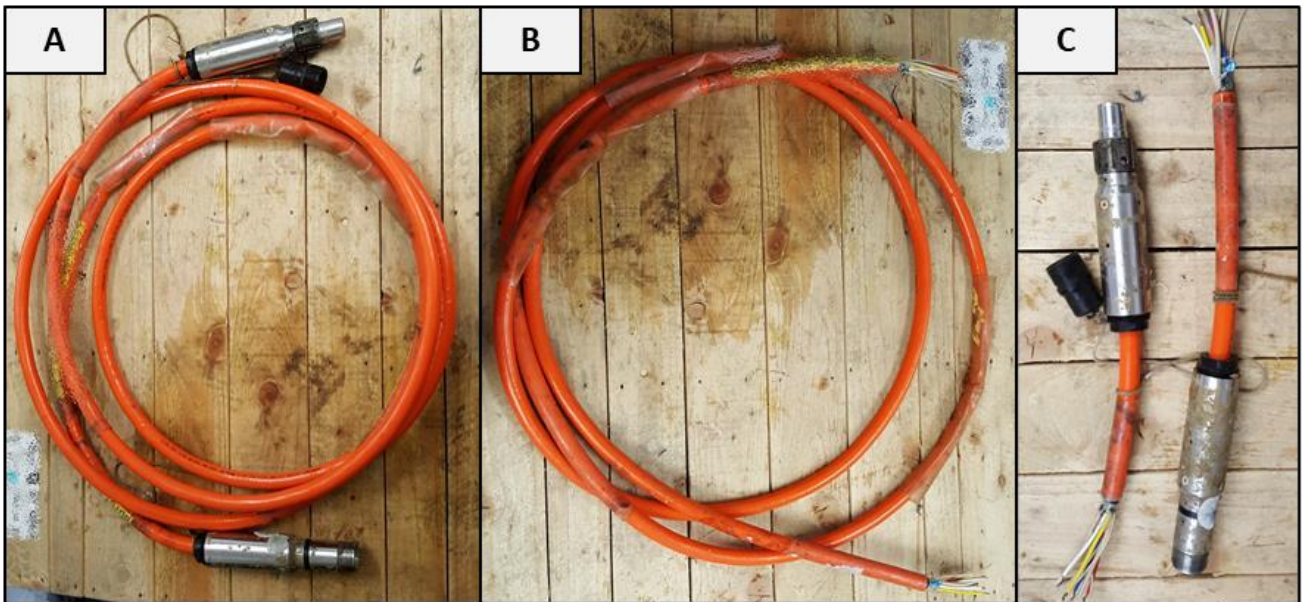
The 1A and 1B EFLs were recovered complete with the cable, male receptacle (MR) and female plug (FP) connectors (see Fig 5). The 1A EFL (A) was acquired in-tact. The 1B EFL was in its constituent parts: cable (B) and both connectors (C). Each EFL consists of four lines 1, 2, 3, and 4 where 1&2 and 3&4 are twisted screened pairs (TSP) (see Fig 6). TSP 1&2 on both EFLs was in use during operation.

Fig 5. Photographs of EFL components denoted A) 1A EFL, B) 1B cable and C) 1B FP (left) and 1B MR (right).

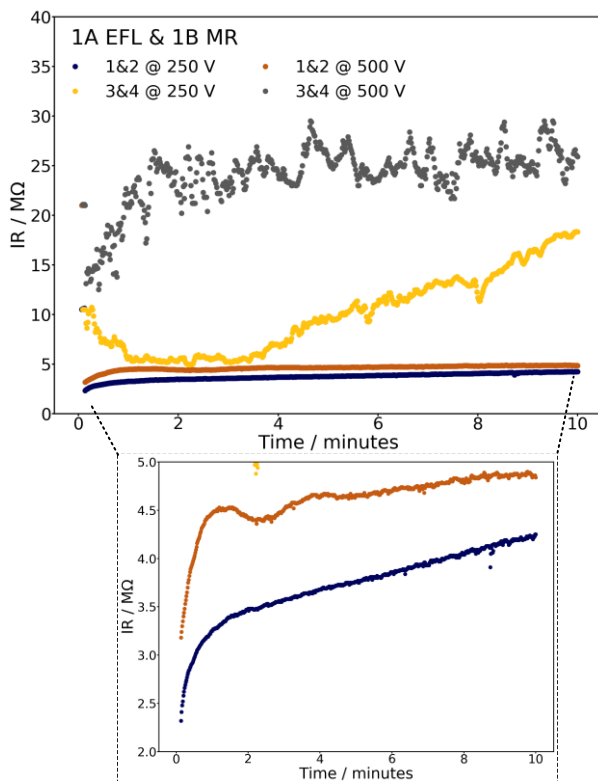
Starting with the 1A EFL connected to the 1B MR, the time-IR plot is given below in Fig 7. As expected, the IR increased with increasing DC voltage for both pairs 1&2 and 3&4. The plot shows that the IR was low for pair 1&2 in the single MΩ compared to 3&4 in the 10's MΩ, consistent with spot IR test readings for lines 1-4. A noisy IR for 3&4 at 250 and 500 V (yellow and grey, respectively) was observed reflecting erratic leakage current. This could indicate the presence of multiple weaknesses in the insulation or, in other words, multiple current leakage paths. In all cases, however, the IR generally increased with time and thus a PI value > 1 is expected – indicating 'questionable' or better insulation integrity.

Fig 7. Time-resistance plot for 1A EFL + 1B MR.

PI values are given for the 1A EFL + 1B MR assembly in Table 4. All PI values were between 1-4, therefore indicating a 'questionable' to 'okay' insulation condition range. The drastic reduction from 3 to 1 for 3&4 at 500 V is a consequence of the noisy IR signal observed for 3&4. The noisy IR renders the PI value unreliable. This highlights the importance of observing the time-IR trends *and* PI values when making conclusions. Overall, noisy IR and low PI values provide a cause for concern regarding the integrity of lines 1-4 of the 1A EFL + 1B MR assembly.

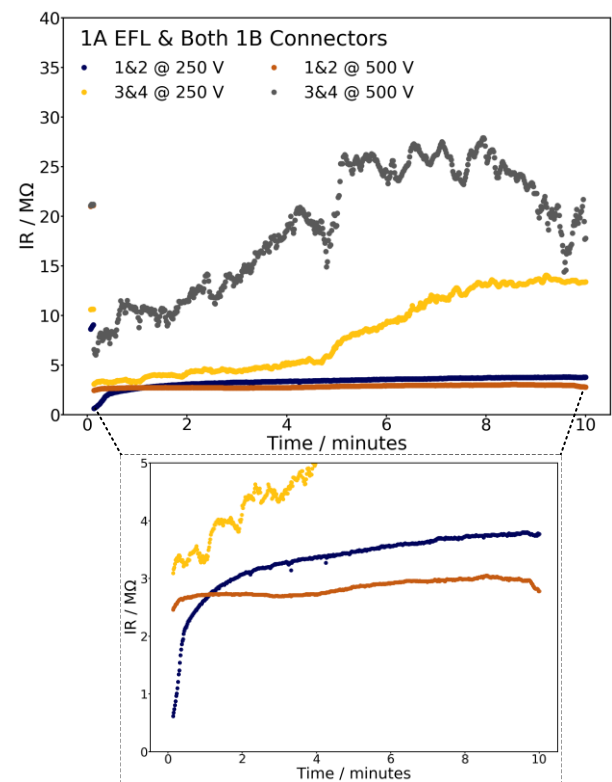
Fig 8. Time-resistance plot for 1A EFL + both 1B connectors.

Similar results, given in Fig 8, were observed for the 1A EFL with both 1B connectors. Noisy IR was observed for 3&4 and similar IR values observed for the pairs at 250 and 500 V. Again, noisy IR could indicate multiple faults in the insulation. For the pair 1&2, the IR was greater at 250 V than the IR at 500 V (the reverse is expected for healthy insulation). This could indicate the presence of a fault in the pair, where absorption current is smaller and leakage current is large due to the presence of contaminants/water ingress. PI values for this configuration (see Table 4) were similar compared to the absence of the 1B FP, with PI between 1 and 2, indicating 'questionable' insulation integrity. Again, the high PI value of 4.0 for 3&4 was deemed unreliable due to noisy IR observed for the pair. Overall, no major changes are evident from the addition of the FP and the lines remained in a 'questionable' state.

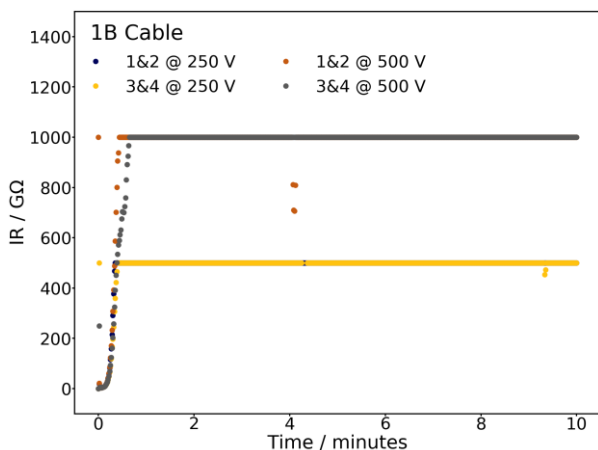
The time-resistance plot for the 1B cable is given in Fig 9. The plot depicts over-range readings for each pair at each voltage (> 500 GΩ at 250 V, and > 1000 GΩ at 500 V). The 1B cable insulation was therefore deemed to be in excellent condition. The over-range values yield the PI values of 1 meaninglessly.

Fig 9. Time-resistance plot for 1B cable.

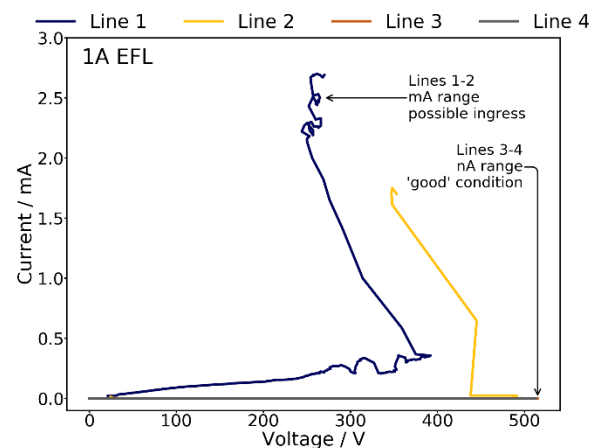
Two notable observations were made for current-voltage curves given in Fig 10 for the 1A EFL: **1)** high currents up to 2.5 mA were exhibited by line 1 and **2)** line 1 was unable to achieve 500 V. Most IR testers limit the voltage when a high current is detected (associated with a short circuit), serving as a protective measure avoiding further insulation degradation. Line 2 also exhibited a momentary current spike to 2 mA. It is possible this is an effect of line 1 since lines 1 and 2 are not screened from each other. Lines 3-4, which reach 500 V, exhibit currents in the nA range. It was deduced that line 1 of the 1A EFL likely suffered from water ingress, and lines 2-4 were in 'good' condition.

Fig 10. 1A EFL ramp test results for lines 1-4.

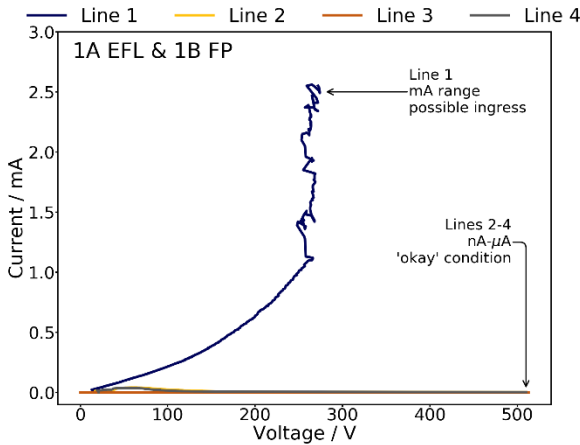
Ramp test results for the 1B FP connected to the 1A EFL, given in Fig 11, were similar to the 1A EFL. High currents were observed for line 1 up to 2.5 mA, and low currents for lines 2-4. For lines 2-4 the current had increased compared to the 1A EFL entering into the low μA range, therefore deemed 'okay'. Overall, line 1 was proposed to suffer from water ingress in this assembly and lines 2-4 in 'okay' condition.

Fig 11. Ramp test results for lines 1-4 for the 1A EFL connected to the 1B FP.

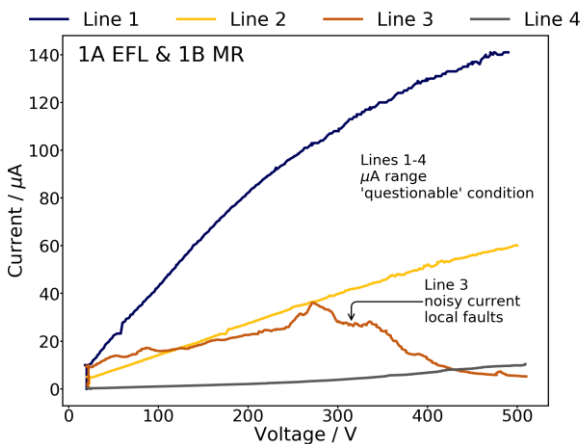
When the 1B MR was connected to the 1A EFL, the ramp test results for line 1 differed compared to other results with the 1A EFL. Fig 12 shows that for all lines 1-4, currents in the μA range were obtained. Current in the mid- μA range is indicative of a 'questionable' condition, applying also to lines 2-4. Noisy current, or 'blips', indicate the possibility of local insulation faults.

Fig 12. Ramp test results for lines 1-4 for 1A EFL connected to the 1B MR.

Worth noting is the fact that the 1A EFL + 1B MR assembly was first to undergo a ramp test. This could explain the lower currents generated during the ramp test compared to previous observations. The DC voltage could have damaged the insulation further so when the 1A EFL underwent more ramp tests, higher currents were observed.

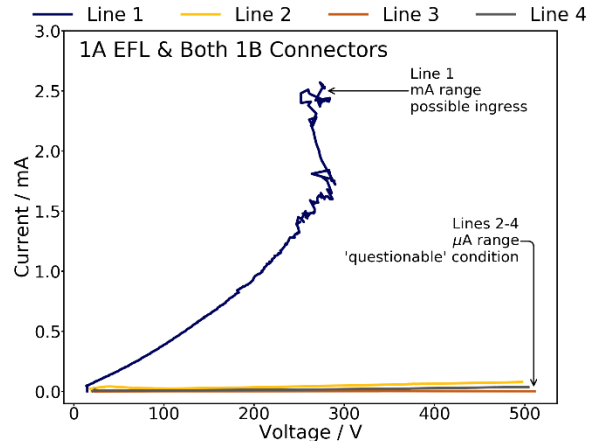
When both 1B connectors were connected to the 1A EFL the current responses, given in Fig 13, were similar to those observed for the 1A EFL and 1A EFL

+ 1B FP assemblies. Line 1 provided currents in the mA range, once again indicating water ingress. The results were consistent with those for line 1 of the isolated 1A EFL. Lines 2-4 exhibited currents in the μA range, with a relatively linear increase in current. Therefore the insulation for lines 2-4 was 'questionable' with no fault types suspected.

Fig 13. Ramp test results for lines 1-4 for 1A EFL connected to both 1B connectors (MR and FP).

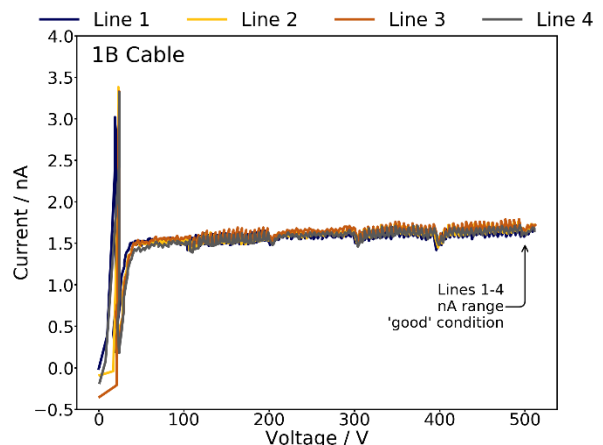
Finally, currents given by the 1B cable (see Fig 14) were extremely low during ramp testing, in the single nA region. Low currents were indicative of excellent insulation integrity for all four lines in the 1B cable. The current traces appear noisy, but this low current noise represents electrical noise from the test setup.

Fig 14. 1B cable ramp test results for lines 1-4.

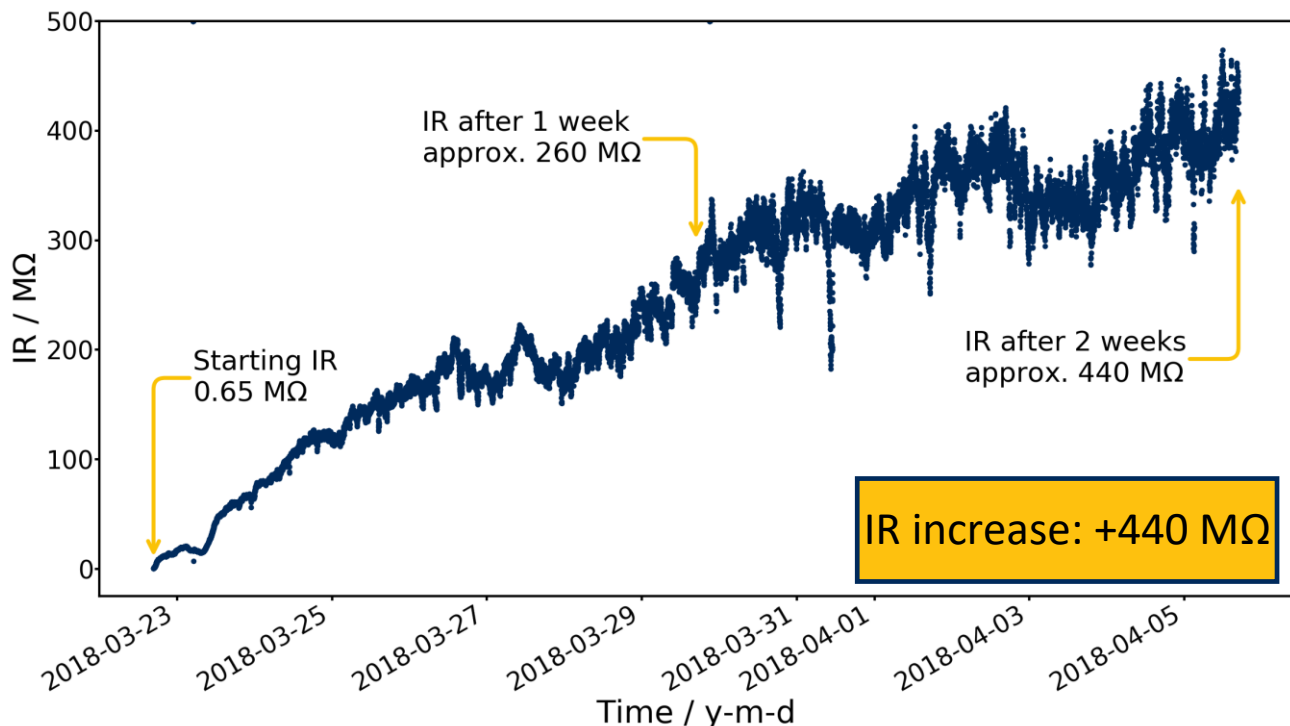
Fig 15. V-LIFE IR for 1A EFL & both 1B Connectors.

The final stage for the EFLs investigated in this paper was to 'heal' and improve the IR with **V-LIFE**. The 1A EFL was connected to both 1B connectors and submerged in saltwater. The pair 1&2 was connected to a **V-LIFE** enabled **V-LIM**. This pair was chosen since these were the operational lines during subsea production and showed significant signs of water ingress according to ramp testing.

Fig 15 provides the **V-LIFE** IR for the EFL assembly. Starting at an IR of approximately 650 k Ω , the system IR increased markedly to approximately 260 M Ω in just one week. After two weeks, the system was at a staggering 440 M Ω . This was a considerable improvement in IR, showing that **V-LIFE** successfully recovered the IR of a submerged EFL with suspected seawater ingress. **V-LIFE** therefore had a positive impact on the insulation integrity of the faulty lines.

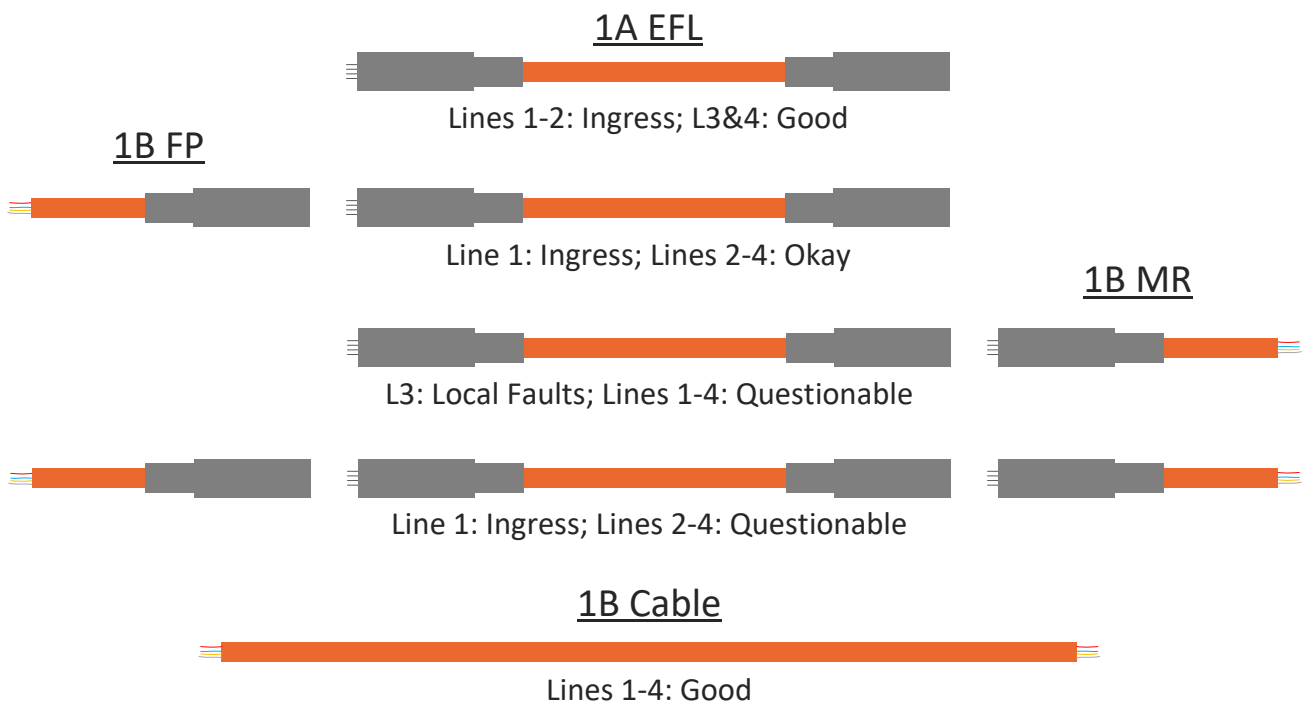
Through product of elimination, three IR testing methods 'spot' testing, time-resistance and ramp testing performed on acquired EFL components deduced the presence of insulation faults, or lack of, and in some cases the type of fault in the 1A EFL and 1B EFL components. Such deductions are summarised in the illustration below. It is hypothesised that channel 1A and 1B EFLs failed due to water ingress in line 1. More specifically, **water ingress in line 1 of the 1B female plug and**

1A electrical flying lead. Furthermore, ramp testing, with support from time-resistance plots, warned of the presence of **local insulation weaknesses for line 3 of the 1B MR.** The remaining lines were in 'okay' to 'good' conditions other than for the 1B MR, which were 'questionable' across the board.
