**THE ROLE OF
LINE INSULATION
MONITORS
& REDUCING COPPER LOSS ON
SUBSEA ELECTRICAL SYSTEMS**

**VIPER
INNOVATIONS**

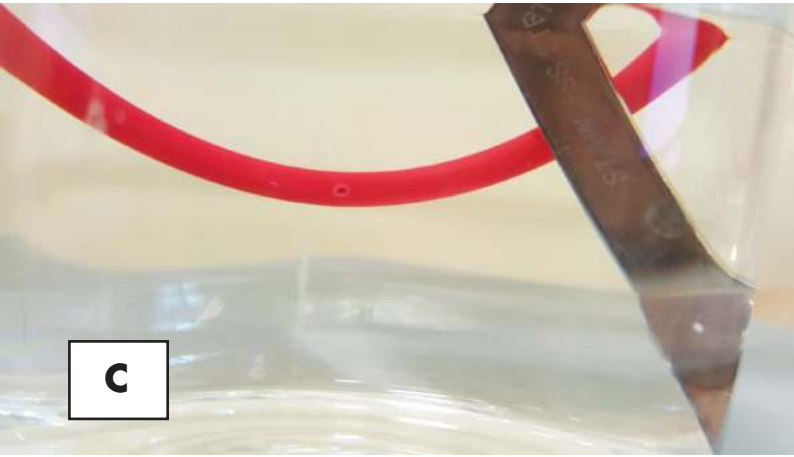
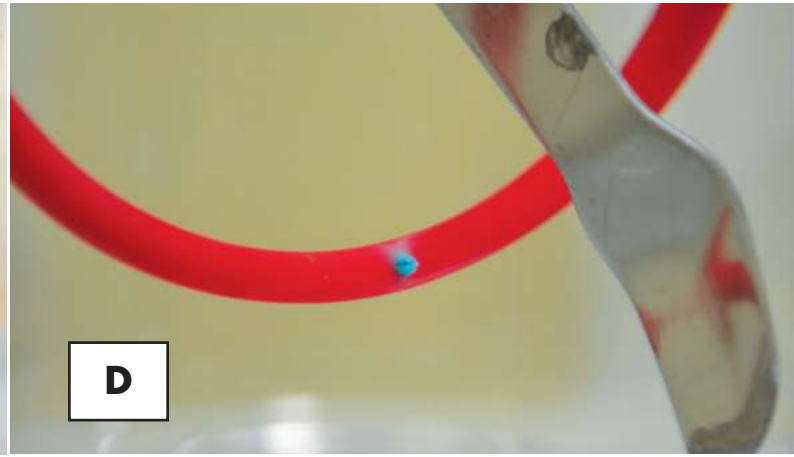
Results of the two-week experimentation can best be summarised with the aid of photographs. Initially an IMD was connected to a damaged wire which was submerged in simulated seawater, and a steel rod was used as the ‘earth’ conductor, which acts as the return connection to the IMD, in the same way as the platform leg or umbilical wire armour would do in a real situation. The two photo references show the damaged wire at the start of the experiment (C) and the wire after the two weeks (D). What can clearly be seen in the second picture is the copper corrosion deposits leaching out of the damaged cable.

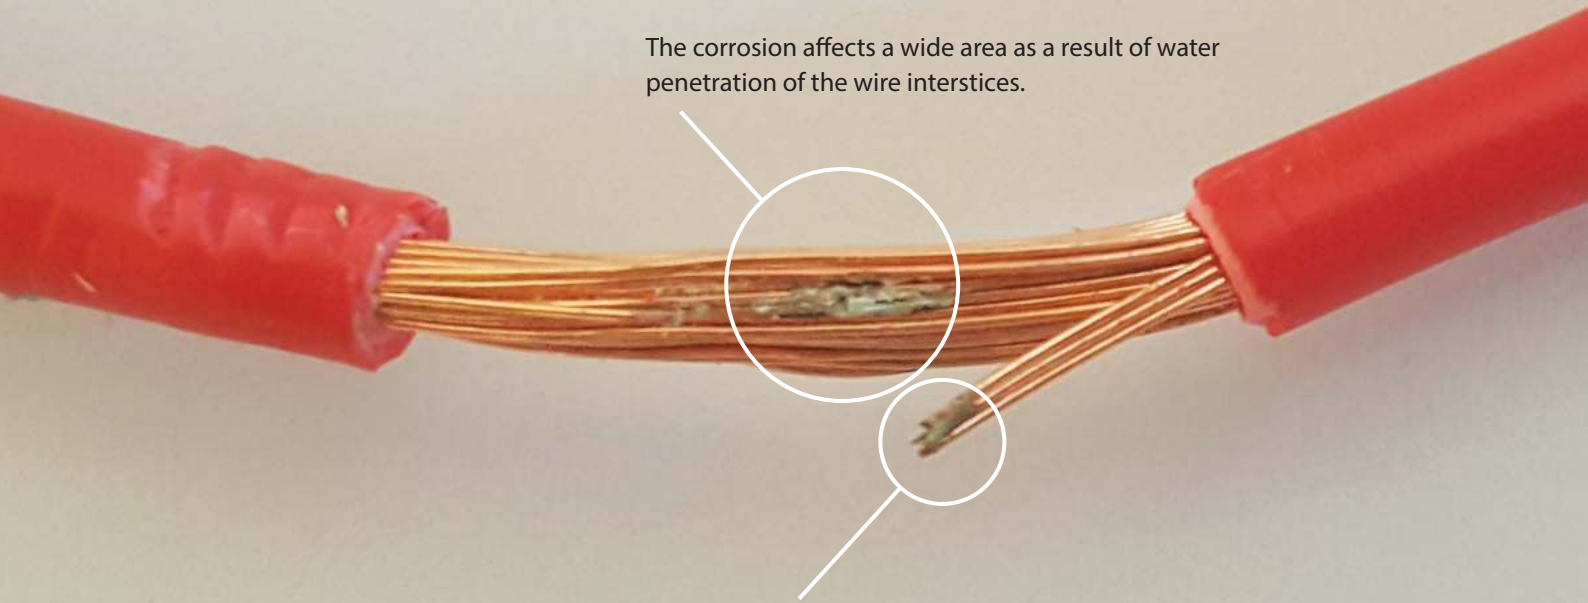
After the experiment concluded, the wire insulation was stripped back to expose any damage to the conductor.

The corrosion affects a wide area as a result of water penetration of the wire interstices.

The copper corrosion has resulted in strands breaking.

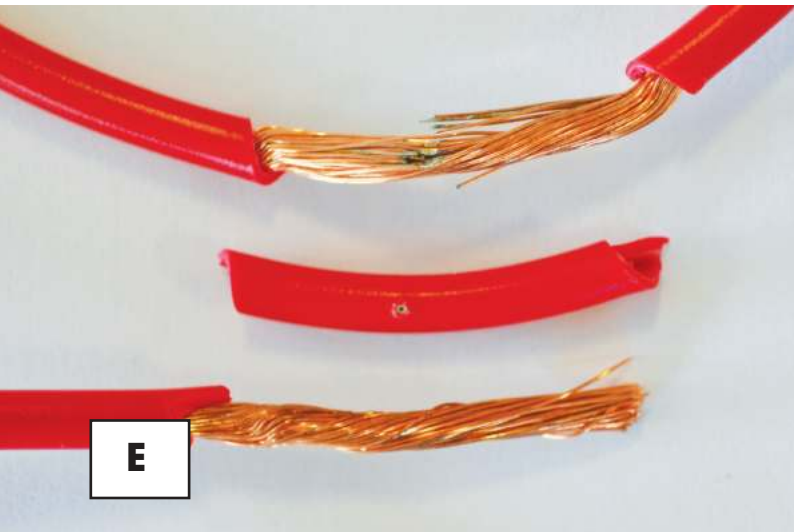
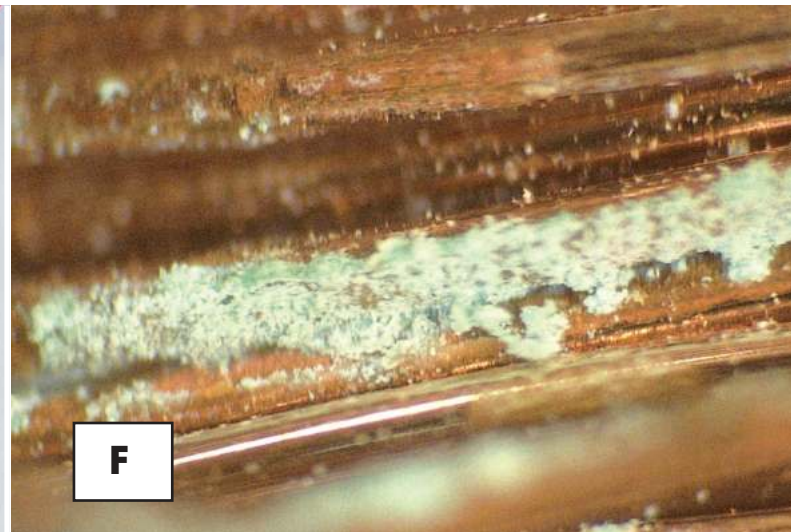
When the cable insulation was stripped away, the blue copper corrosion and green copper corrosion deposit was observed around the immediate area of damage. The image (E) also shows the breaking of copper strands in the cable, where two or three strands are broken. In (E) the top wire is the corroded wire after the two week immersion energized by an IMD and the bottom wire is a length of the virgin wire for comparison purposes. The image in (F), taken via a microscope not only shows the corroding copper (see the strand at the top of the image) but also the green copper corrosion deposit.

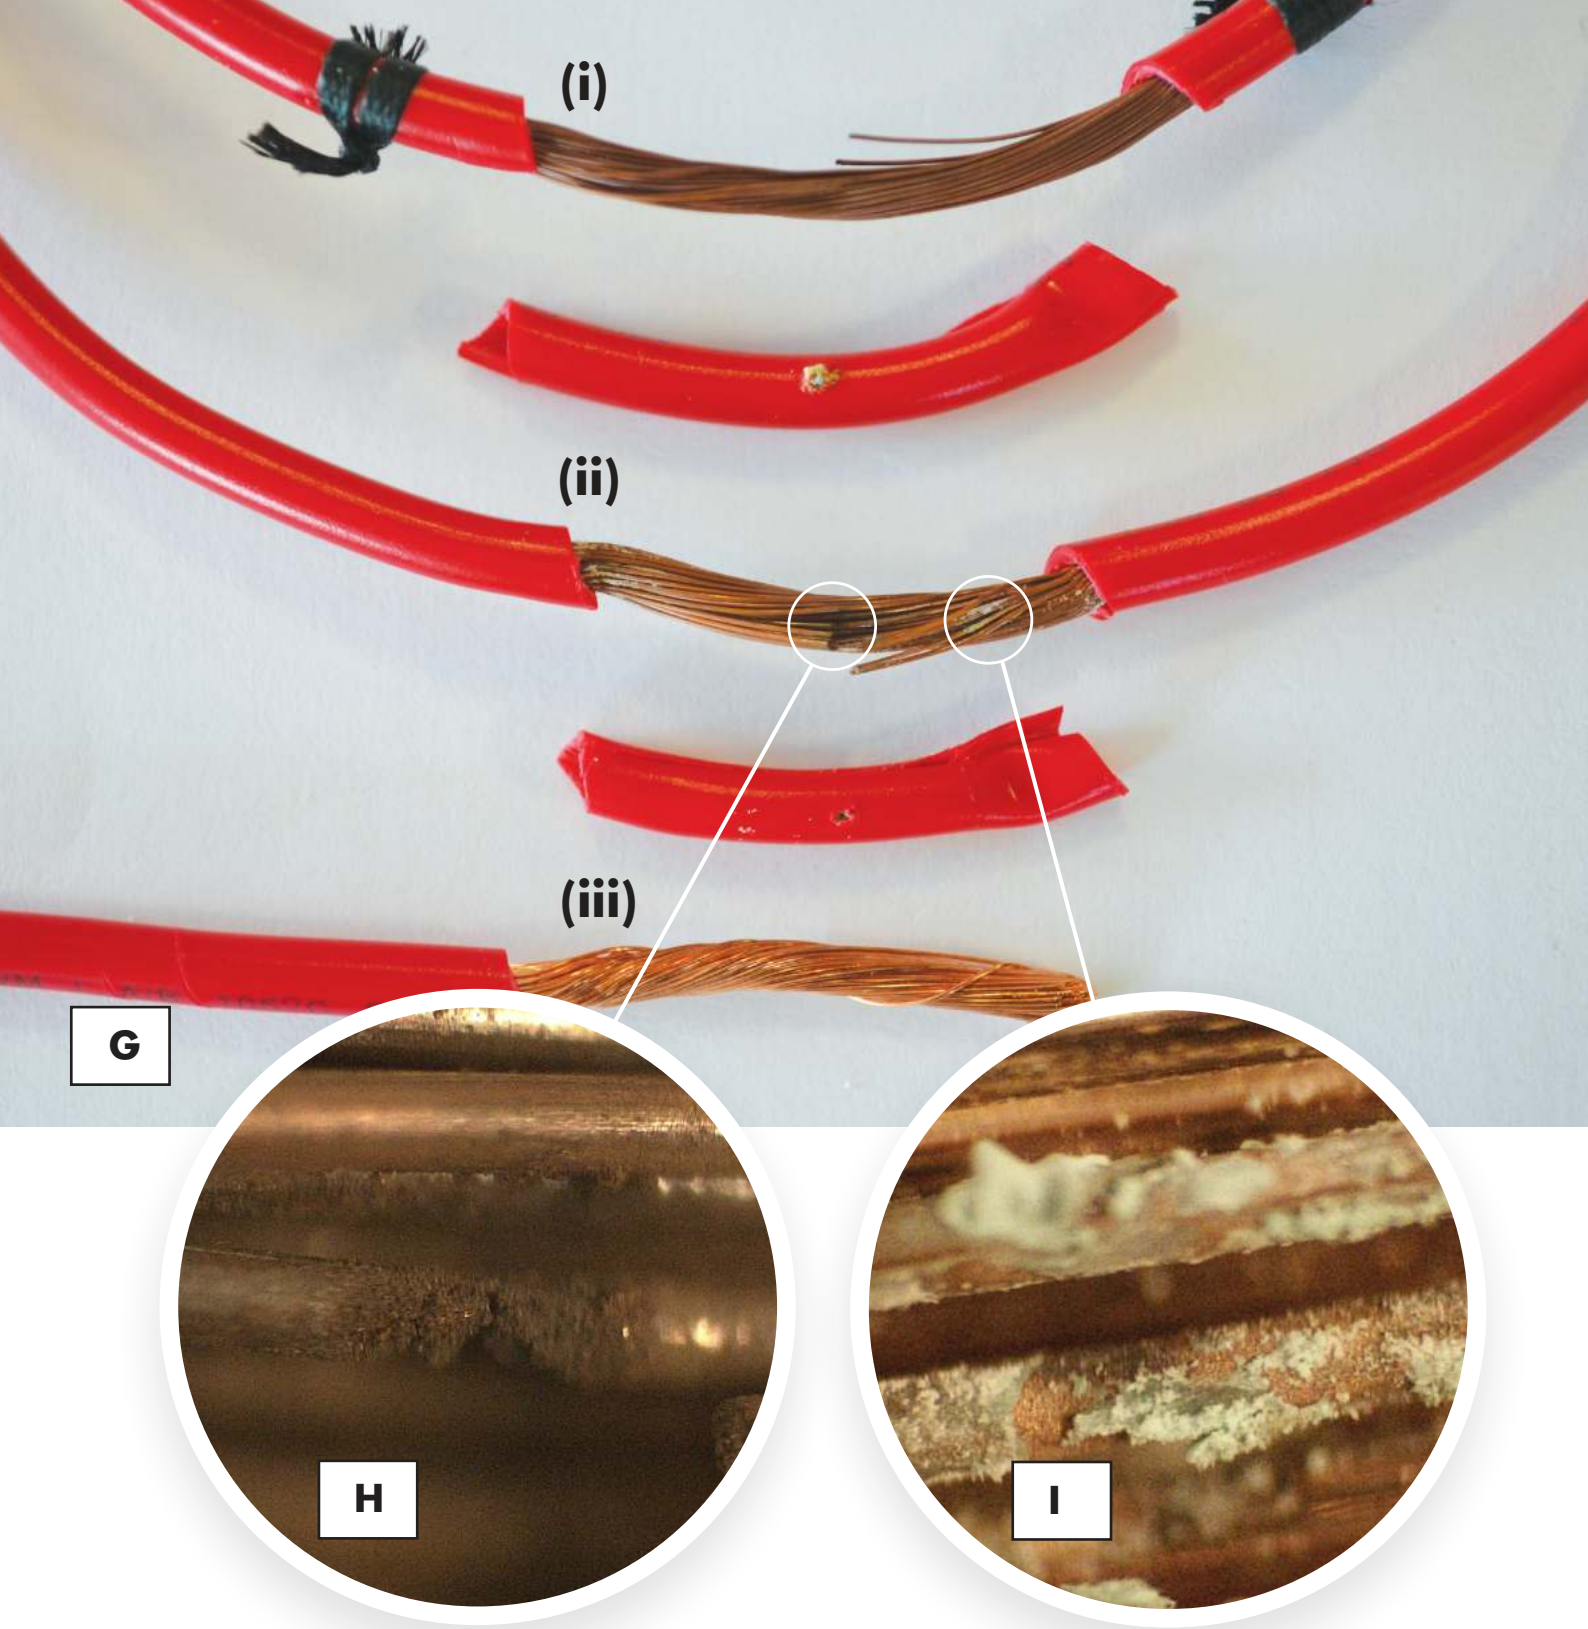
G

The copper on both wires (G(i) and (ii)) appears severely tarnished compared to the clean virgin copper wire (G(iii)). This indicates that water ingress was not inhibited throughout the experiment, with copper loss occurring throughout the cable and not just at the place of the fault in the insulation.

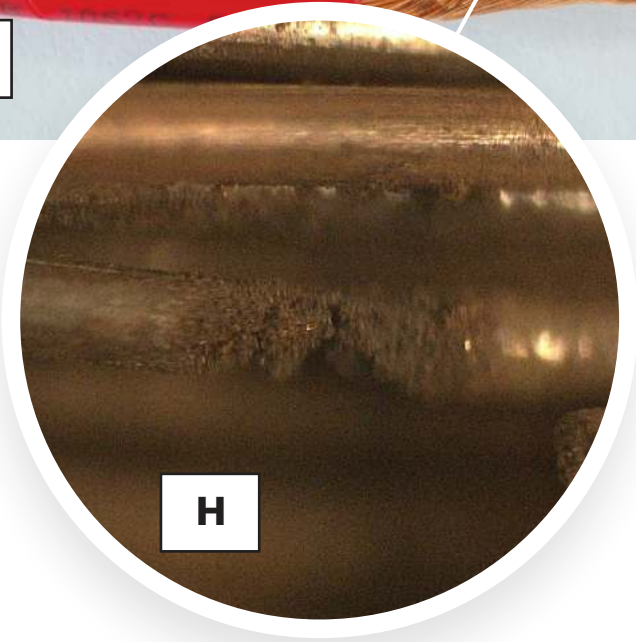
H

At least five strands of copper have been affected in one of the wires, where a significant loss of

copper has occurred – clearly seen in the optical photo (H). This photo also shows that the copper wires were broken due to the loss of copper in the area.

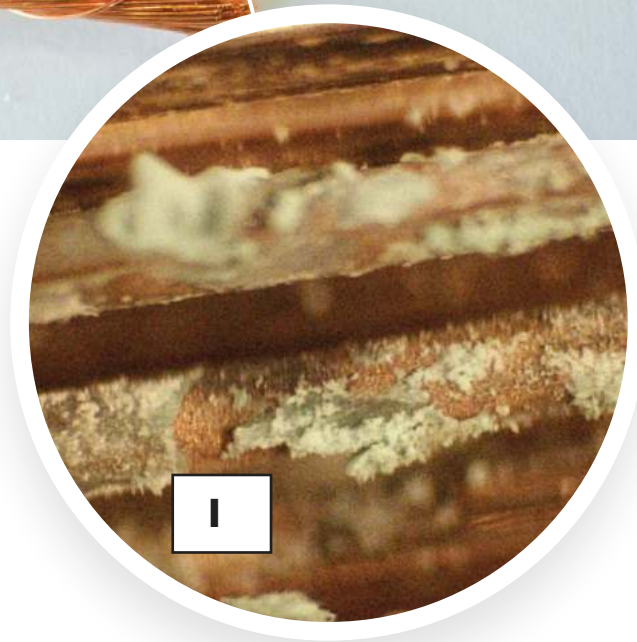
I

It should also be noted that when the wires were stripped back and dried, there was evidence of NaCl crystals (shown in photo I), confirming that the salt water had in fact penetrated the wire significantly.
