KANGEAN GAS FIELD

RECOVERING A FAILING SYSTEM WITH V-LIFE

INSULATION REMEDIAL SYSTEM SOLUTION FOR LOW INSULATION RESISTANCE PROBLEM ON THE SUBSEA ELECTRICAL FAILURE OF TSB CONTROL SYSTEM

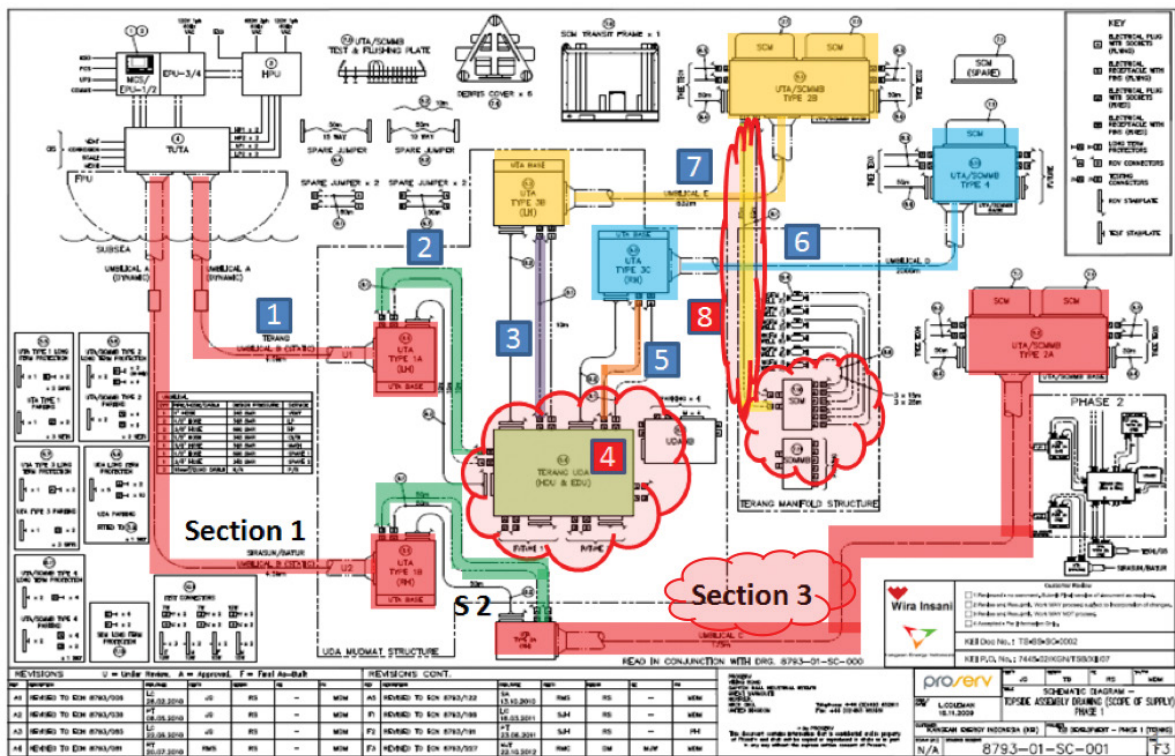
Fig. 1

This **V-LIFE** process takes place on the section of the subsea control system shown in figure 1 below (Clouded section) i.e. the section that is exposed to seawater.

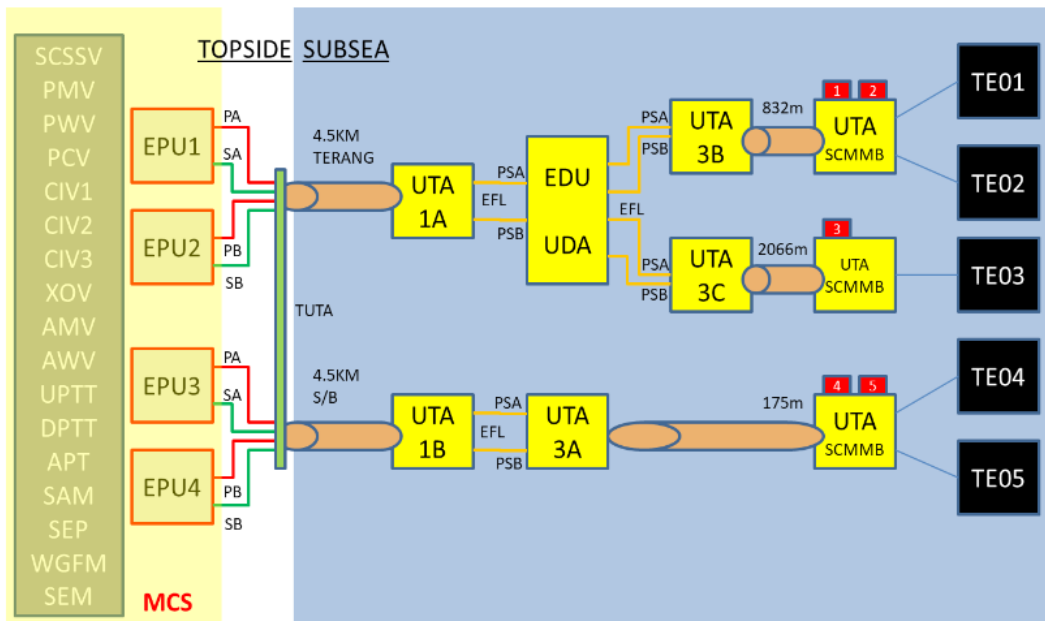
Fig. 2

Figure 2 below shows the configuration of a typical Topside-Subsea control system.

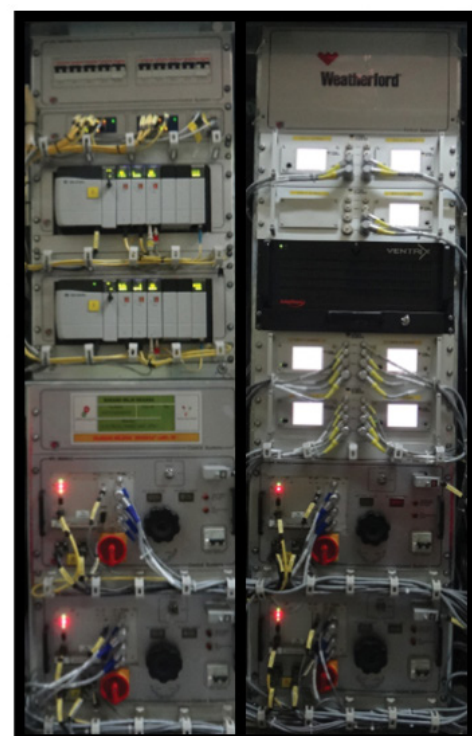
Fig. 3

The Insulation Remedial equipment is connected to the topside control system with the configuration shown in figure 3 below.

It must be noted that the formation of the barrier element, being directly in contact with the seawater, can dissolve over time or be wasted away.

This results in an increase of current leakage which in turn promoting the generation of new barrier element replacing the eroded earlier formation. The continuous supply of the **V-LIFE** signal from the topside will perpetually maintain this process cycle. Thus this process is a self – maintaining process.
