Failure Investigation

Root-Cause Analysis of Failed Submerged Electrical Cables

Dr. A. R. Langley

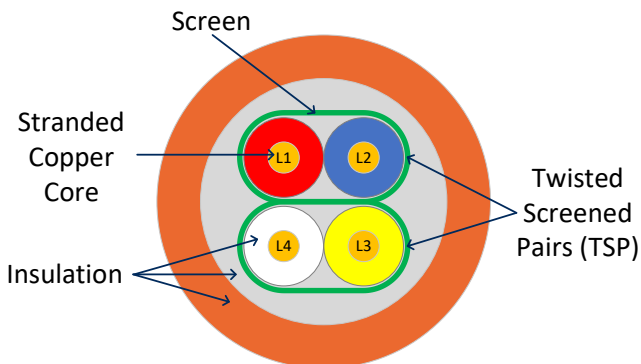
Cable Cross-Section

The 1A and 1B EFLs were recovered complete with the cable, male receptacle (MR) and female plug (FP) connectors (see Fig 5). The 1A EFL (A) was acquired in-tact. The 1B EFL was in its constituent parts: cable (B) and both connectors (C). Each EFL consists of four lines 1, 2, 3, and 4 where 1&2 and 3&4 are twisted screened pairs (TSP) (see Fig 6). TSP 1&2 on both EFLs was in use during operation.

Fig 6. Cross-section of acquired EFL cables.
