**THE ROLE OF
LINE INSULATION
MONITORS
& REDUCING COPPER LOSS ON
SUBSEA ELECTRICAL SYSTEMS**

**VIPER
INNOVATIONS**

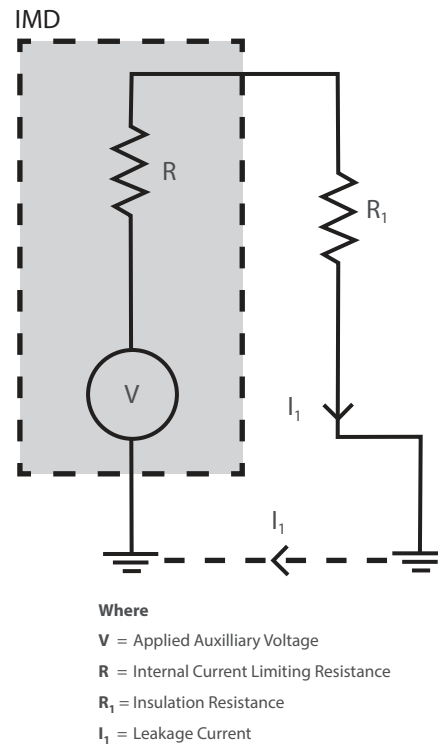
fig.1

IMD is to apply a voltage between the copper conductors in a cable and earth in order to measure the current that flows. The illustration above (fig.1) shows the equivalent circuit of the conductor to 'earth' connection.

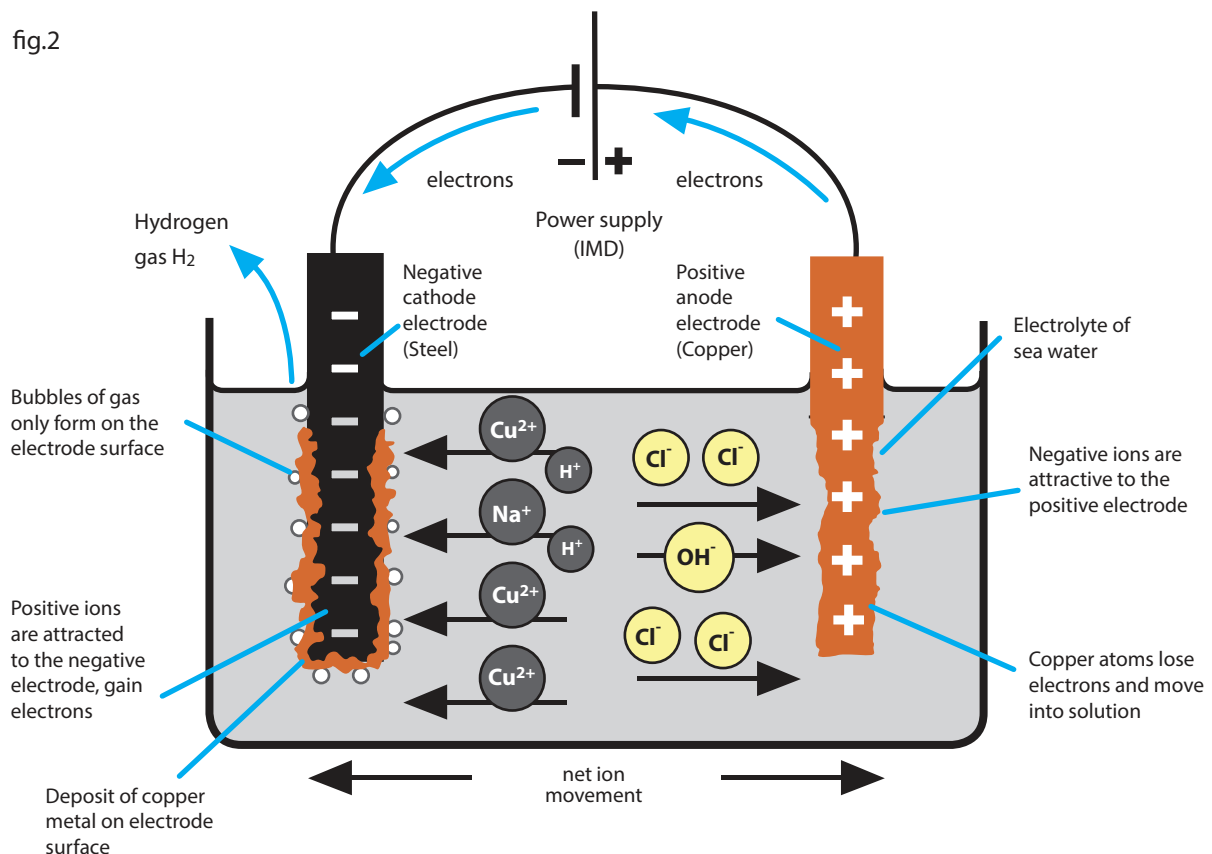
fig.2

Referring to fig.2, when you apply a dc current to a seawater solution using a copper anode, the chloride ions, termed anions, will move towards this positive electrode. Whilst the positively-charged sodium ions (the cations), will migrate towards the negative electrode (the cathode) which is the steel wire armour. The migrating ions carry charge through the solution and hence help to complete the circuit.

In summary, the result of the IMD being connected is that the current flow being driven by the IMD results in copper ions moving into solution, thereby causing copper loss at the wetted surface of the copper conductor. In theory, hydrogen gas is also formed at the cathode (the steel wire armour).
